Gas Supersaturation Monitoring Report for Spill Below Bonneville Dam March 10-13, 2001

U.S. Fish and Wildlife Service Columbia River Fisheries Program Office 9317 N.E. Highway 99, Suite I Vancouver, WA 98665 November 27, 2001

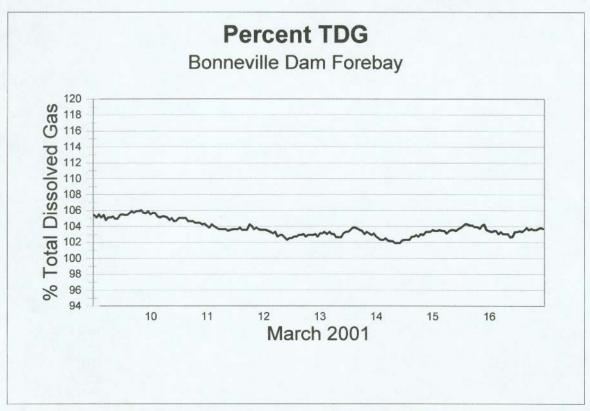
Figure 4. Percent TDG in Bonneville Dam forebay - March 10-16, 2001.

Figure 4 displays percent TDG in the Bonneville Dam forebay. Ambient TDG levels ranged from 101.9-105.7 % from March 10-16.

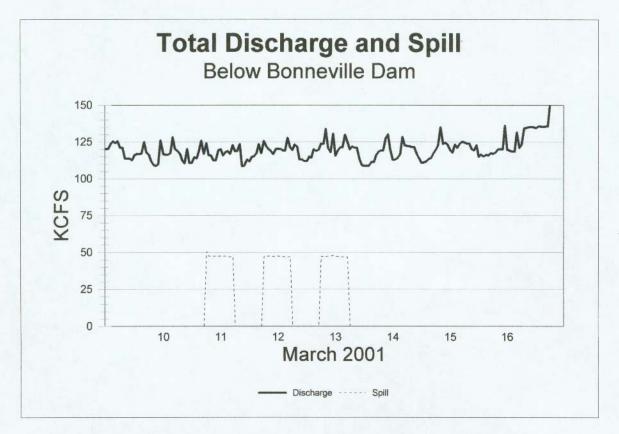
Figure 5. Total discharge and spill from Bonneville Dam - March 10-16, 2001.

Figure 5 shows total discharge and spill at Bonneville Dam during the spill period. Total discharge varied from 108-157 Kcfs. Spill volume remained almost steady during each of the three spill periods at about 47 Kcfs. Tailwater elevations varied from 10.8-11.4 feet, and averaged 11.1 feet from March 10-13. The depth levels recorded by the USFWS pressure gauge 1 near Ives Island during the spill period ranged from 0.43-1.13 feet. During the spill period the maximum depth over the chum redds varied from a few inches over the redds on the margins of the wetted area, to1.5-2 feet over the redds in the deeper area.

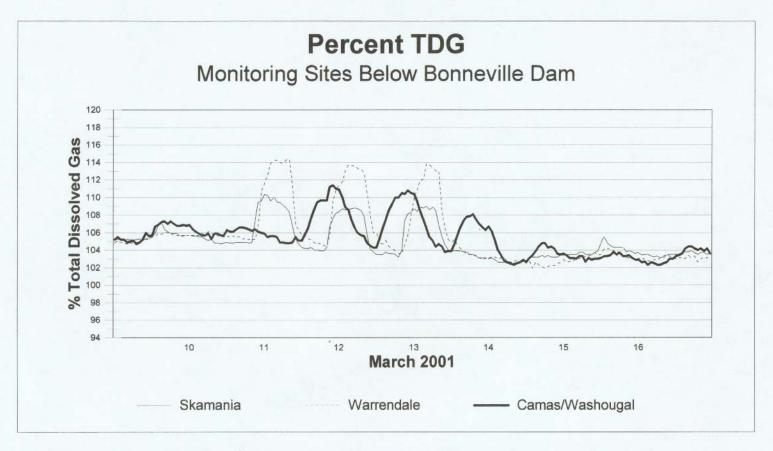
Figure 6. Percent TDG at Skamania, Warrendale, and Camas Washougal monitoring sites, March 10-16, 2001.

Figure 6 compares the TDG readings taken at the USGS sampling stations downstream of Bonneville Dam. None of the readings went above 114.3% from March 10-16. At the Skamania monitoring station recorded TDG levels varied from 102.3% during non-spill periods, to a high of 110.4% during spill perods. Recorded TDG levels at the Warrendale monitoring station varied from 102.1% during non-spill periods, to a high of 117.5% during spill periods. The TDG levels recorded at the Camas/Washougal monitoring station varied from 101.3% from the non-spill periods, to a high of 112.7% from the spill periods. There was about an 18 hour travel time for the water mass passing the Skamania and Warrendale monitoring sites to the Camas/Washougal monitoring site.

PH2 had first use priority over Powerhouse 1 (PH1) during the March 2001 spill. The TDG levels recorded at Skamania were lower than the TDG levels recorded at Warrendale. These results were similar to those in 2000. During the March 2000 spill, when PH2 had greater use priority, TDG levels recorded at Skamania were lower than the TDG levels recorded at Warrendale. The new fish bypass system at PH2 allowed for the change of first use priority to PH 2 rather than PH1. In previous years PH1 had first use priority. During the March 1999 spill when PH1 had greater use priority the TDG levels recorded at Skamania were higher than the TDG levels recorded at Warrendale.

Total dissolved gas levels recorded at the Skamania and Warrendale monitoring stations near the Bonneville Dam tailrace did not exceed 120%. TDG levels recorded at the Camas/Washougal monitoring station (RM 122) did not exceed 115%.

The fall chinook and chum salmon spawning areas along the Ives Island complex are on the Washington side of the Columbia River just upstream of the Skamania monitoring site. First use priority of PH2 over PH1 appeared to help reduce TDG levels along the Washington side of the Columbia River at the Skamania monitoring station when compared to TDG levels recorded for the same time period at the Warrendale monitoring station along the Oregon side of the Columbia River.
